WR2300 WAVEGUIDE SWITCH INSPECTION REPORT

Doug Horan

January 18, 2005

The WR2300 four-port waveguide switches in the APS 350MHz rf systems were visually inspected on January 4, 2005, under Work Request #16364. This work included visual inspection of the waveguide interior of the switches, plus the exterior motor drive components. Photographs were taken at all inspection points.

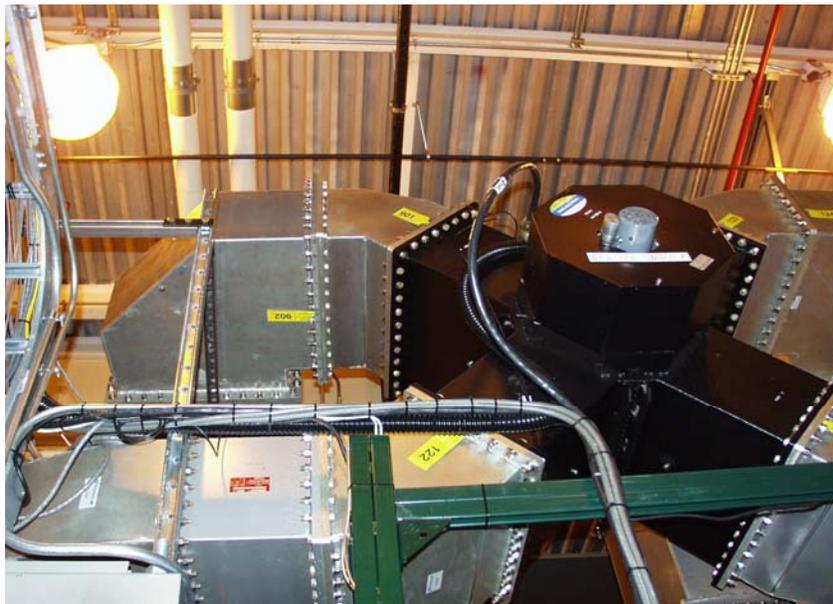
Figure 1 – Waveguide Switch #1

Access to the interior of this waveguide switch was made by removing the 45° miter at port #4 of the switch (at flanges #901 and #902 – see figure 1):

Note: Future inspections of waveguide switch #1 will be done by removing waveguide at port #3. This access point provides a better view of the switch vanes. However, supplemental support of the existing waveguide at port #3 of the switch will need to be designed and installed before the waveguide can be safely removed from port #3.

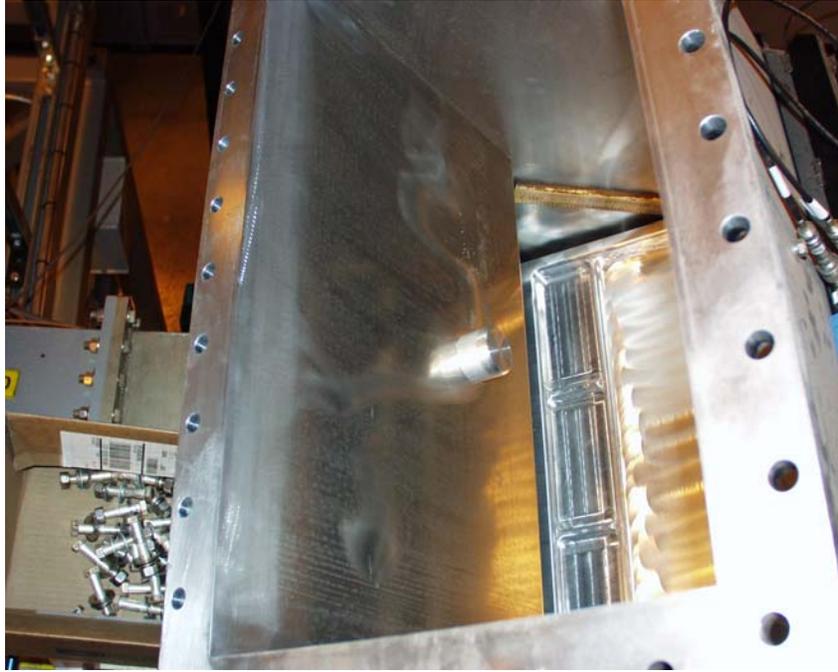
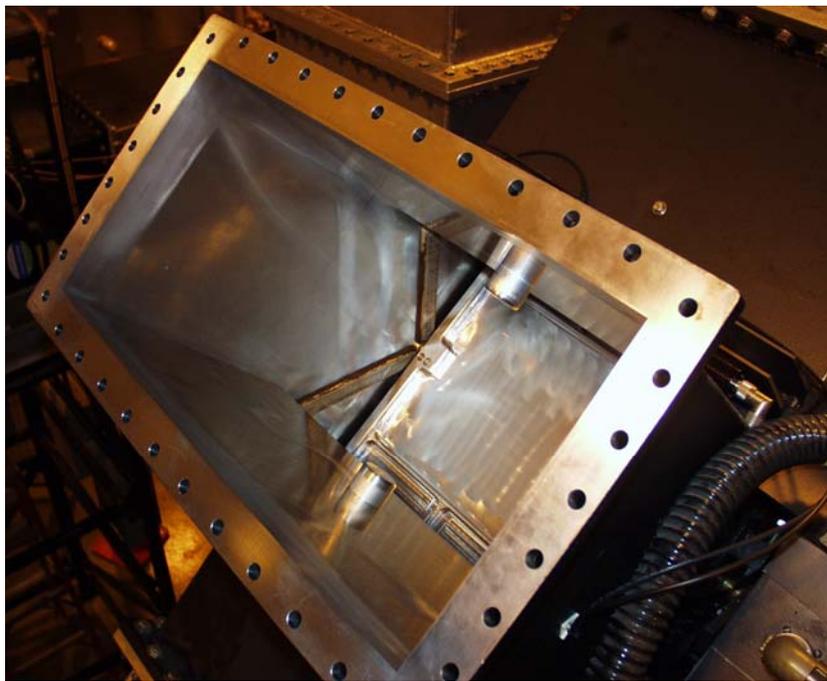
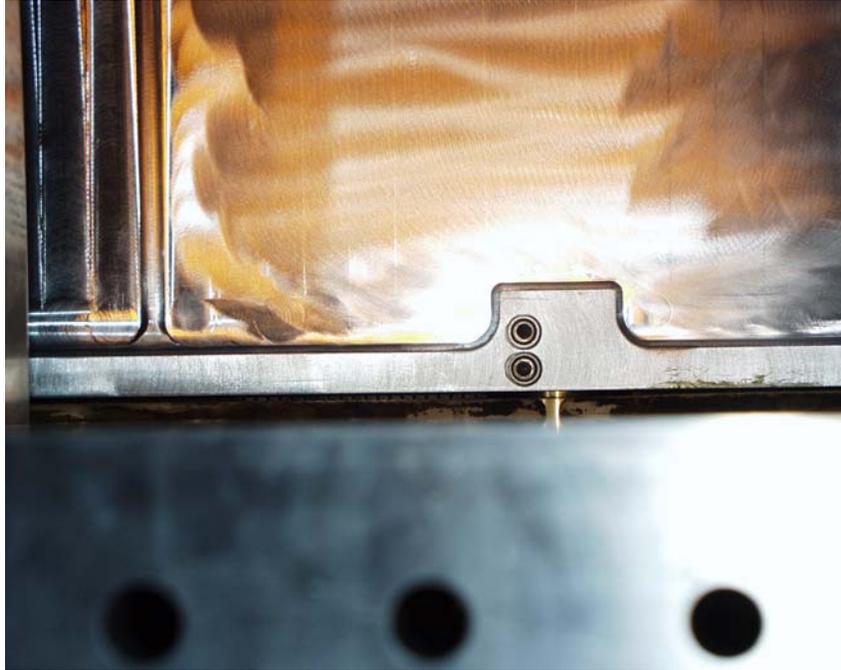
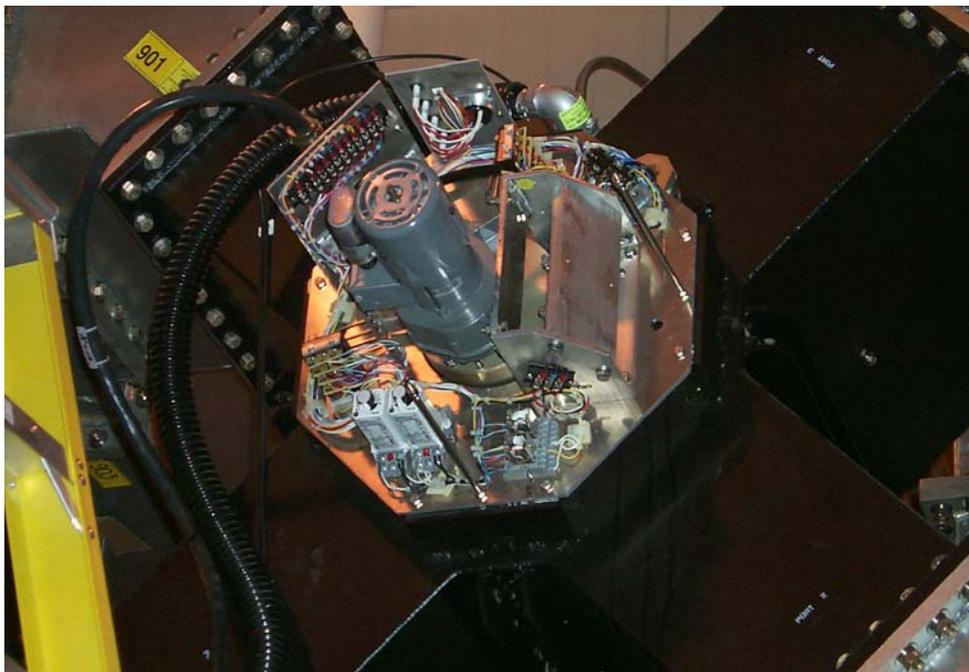
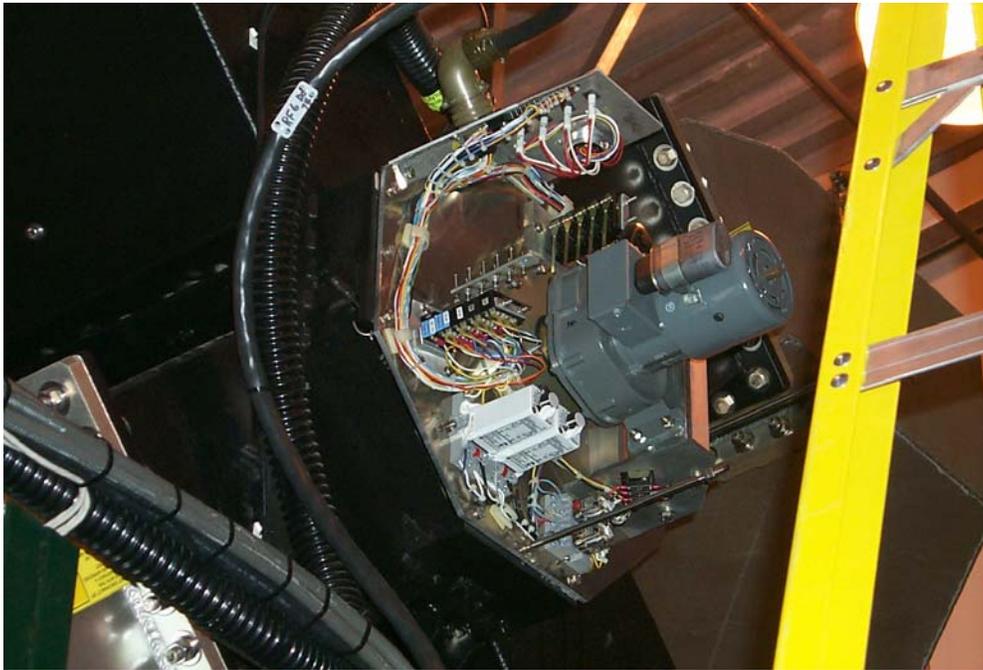
The interior of the waveguide switch showed no signs of arcing or excessive wear on rf contacts, and was clean and free of foreign matter. The following figures are interior views of the switch:

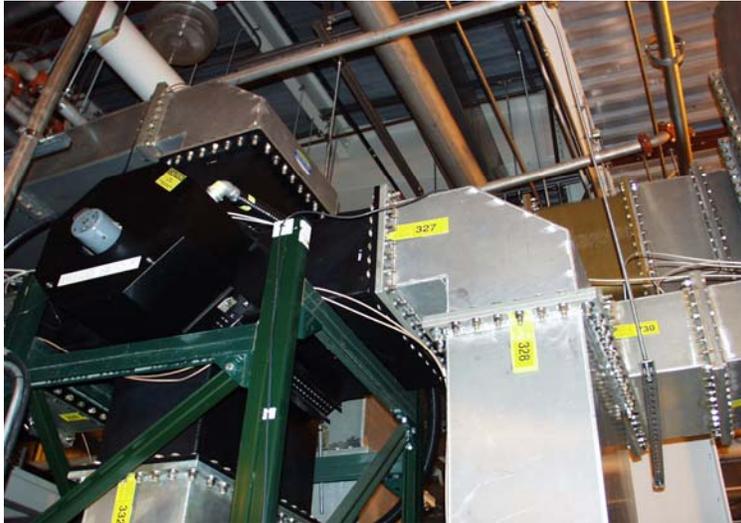
Figure 7 – Waveguide Switch #2

Access to the interior of this waveguide switch was made by removing the 90° miter at port #3 of the switch (at flanges #327 and #328 – see figure 7):

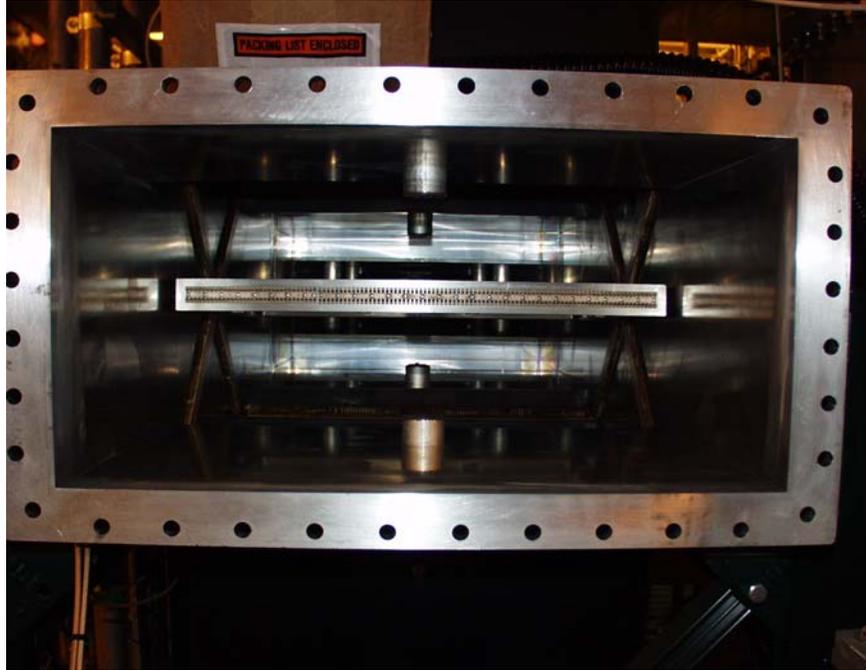
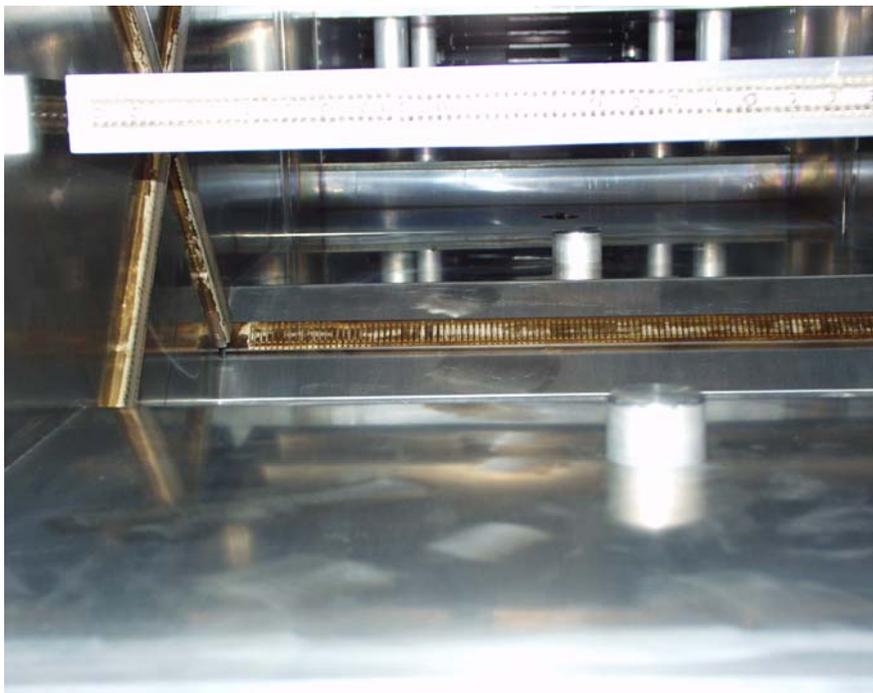
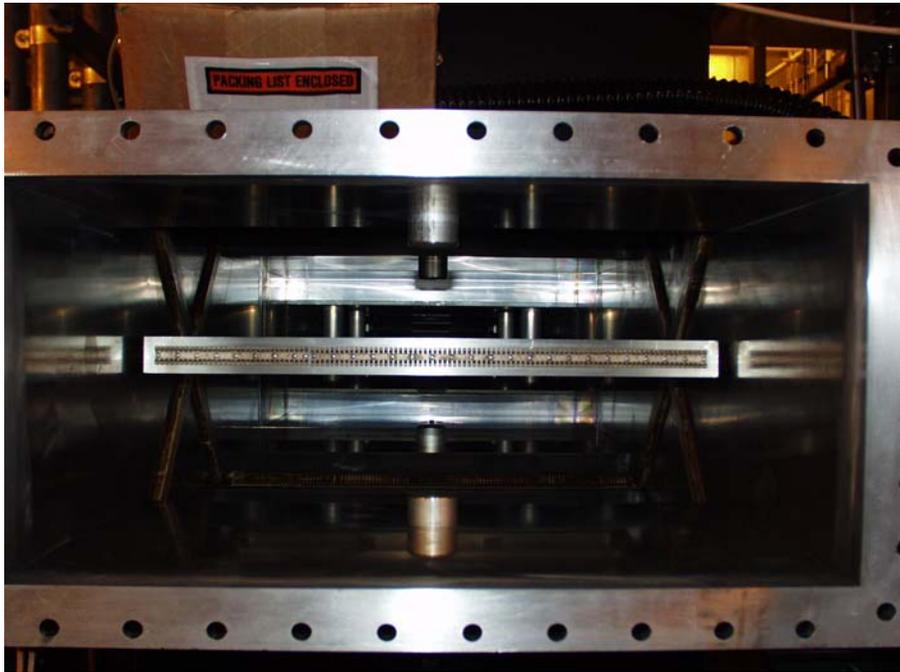
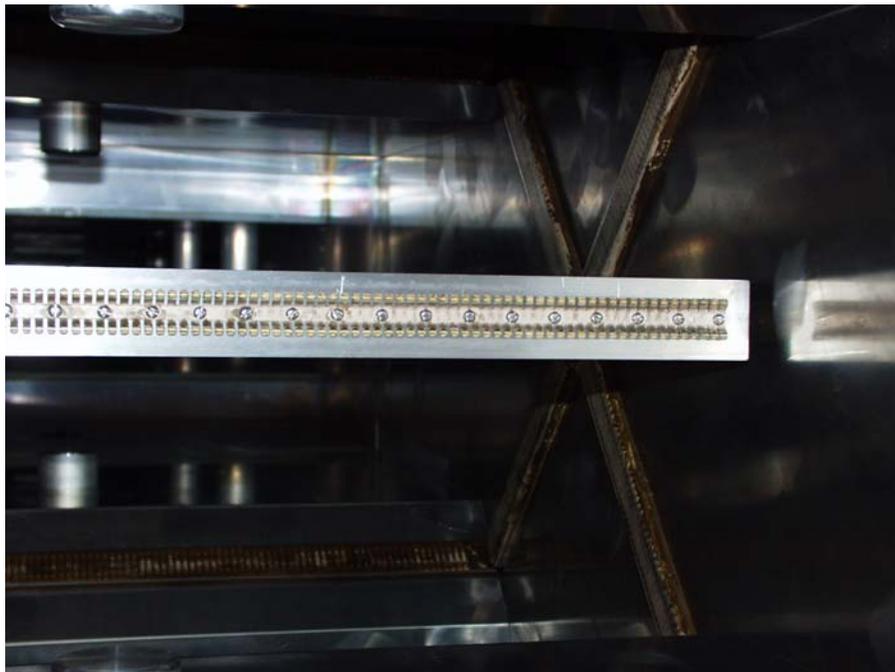
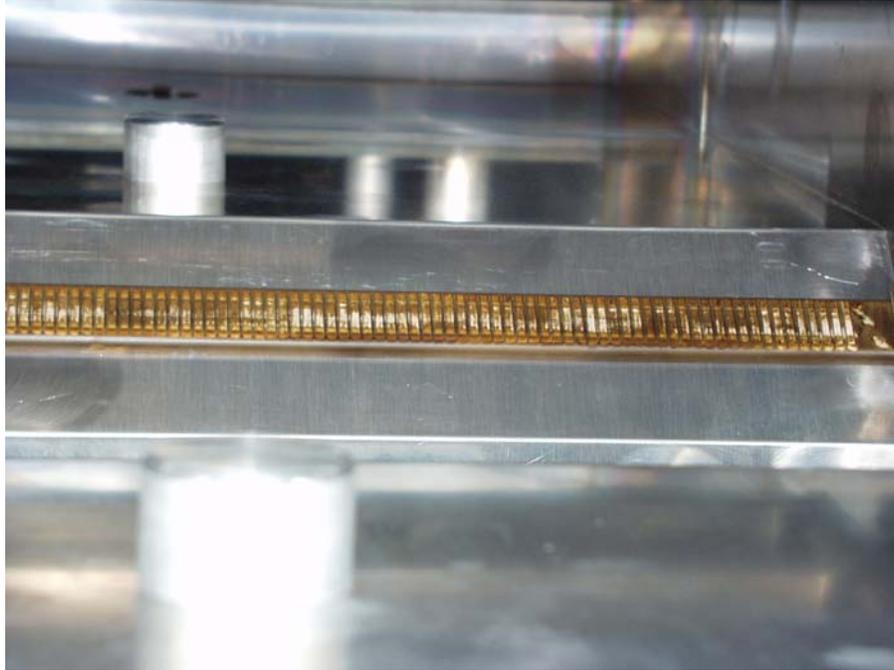
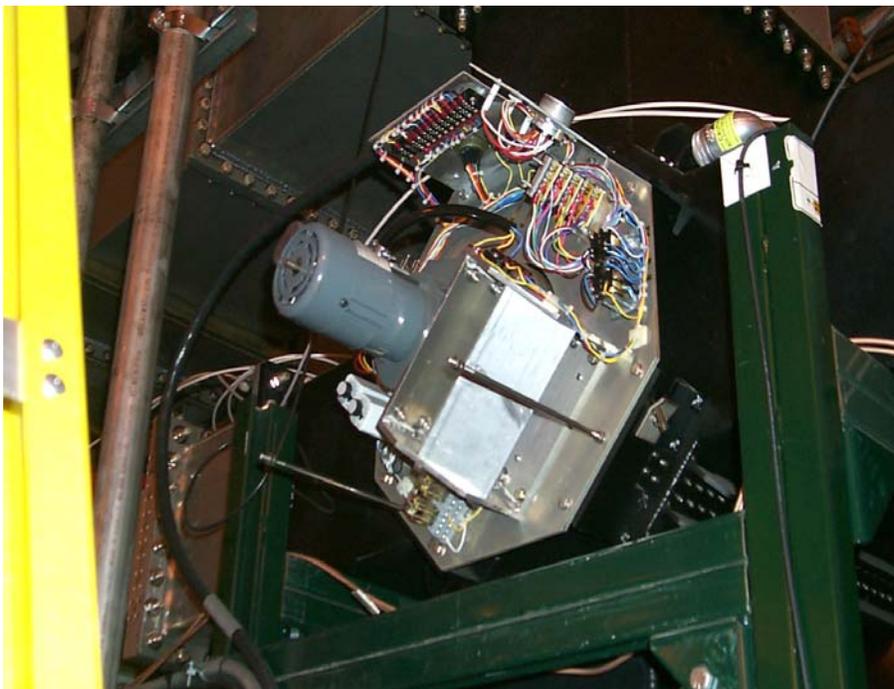
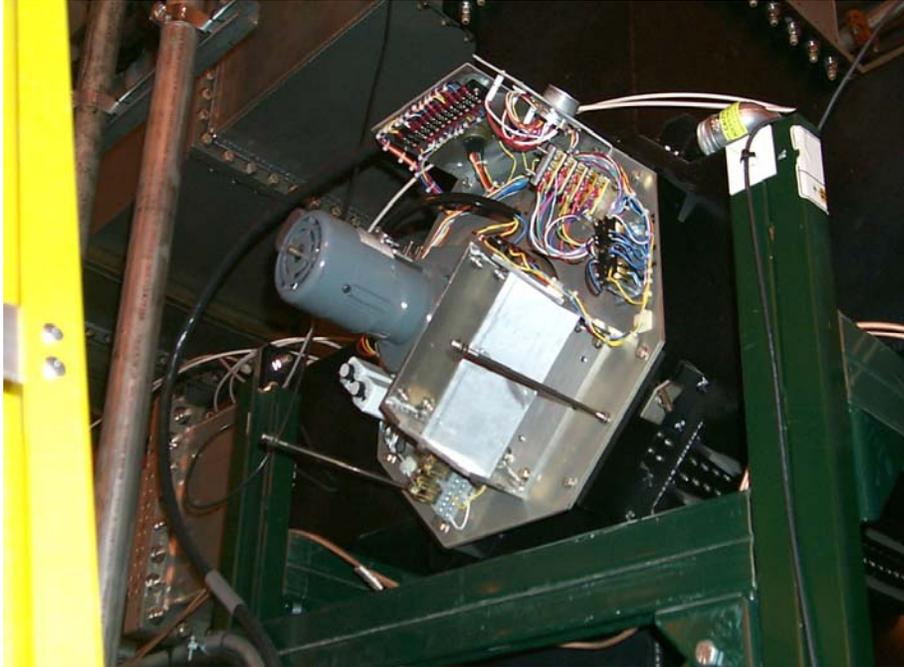
The interior of the waveguide switch showed no signs of arcing or excessive wear on rf contacts, and was clean and free of foreign matter. The following figures are interior views of the switch:

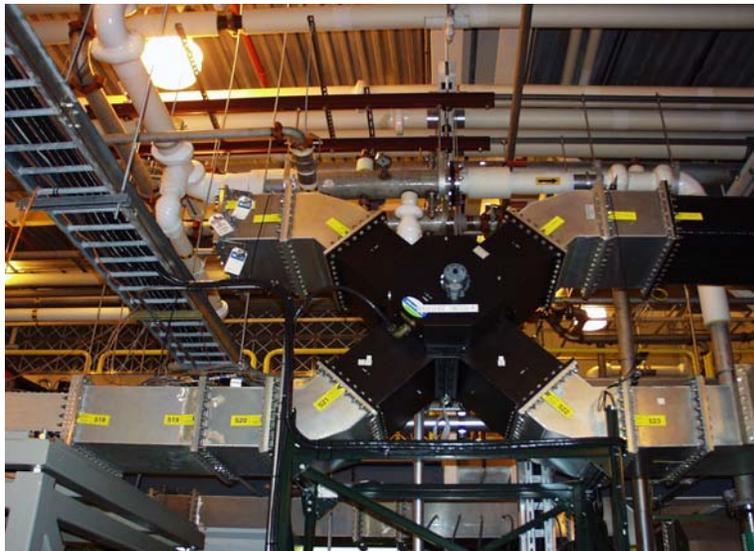
Figure 15 – Waveguide Switch #3

Access to the interior of this waveguide switch was made by removing the 45° miter and straight waveguide/shorting plate combination terminating port #3 of the switch (see figure 15):

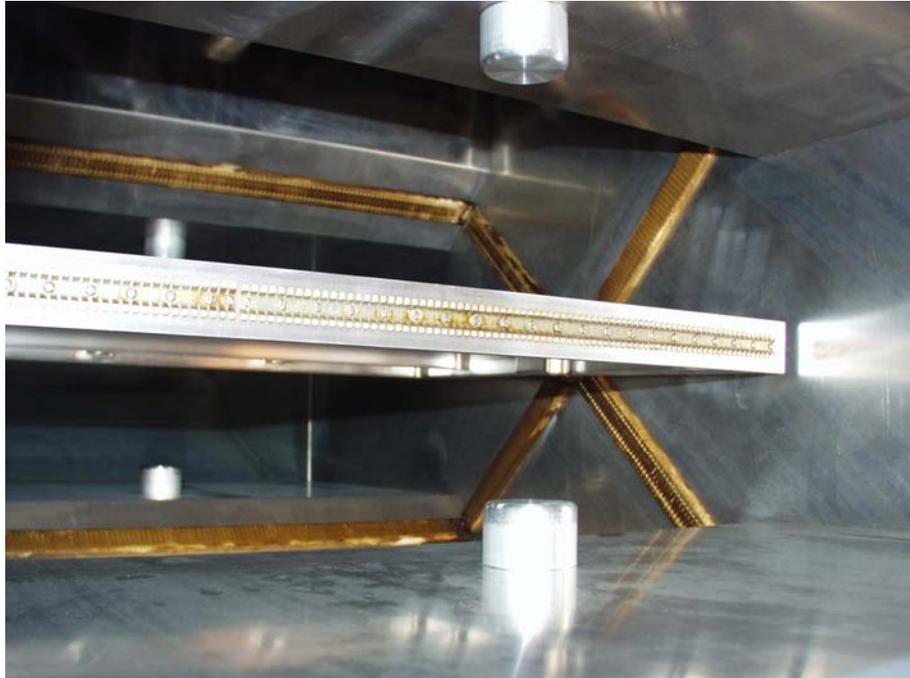
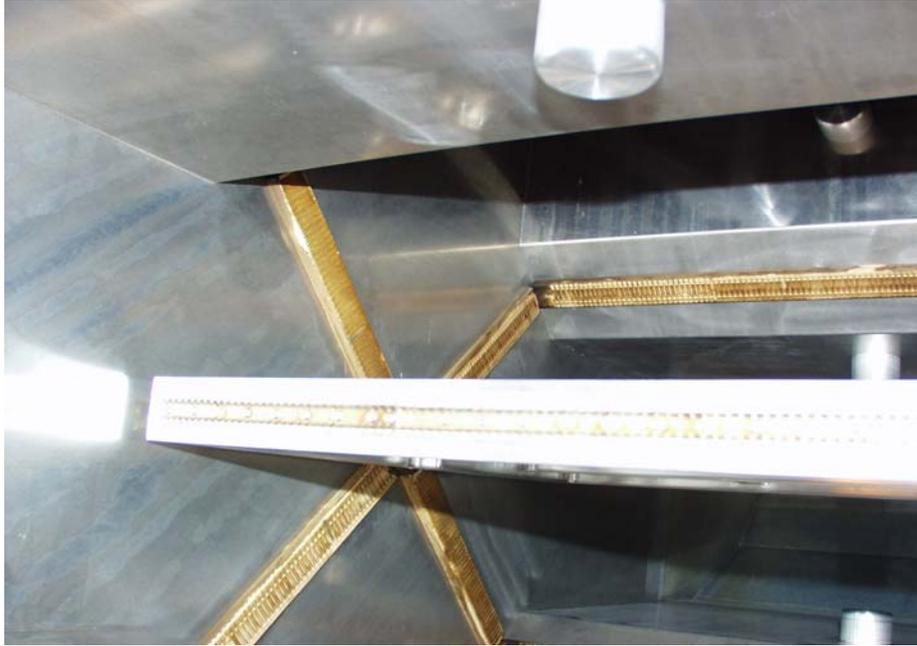
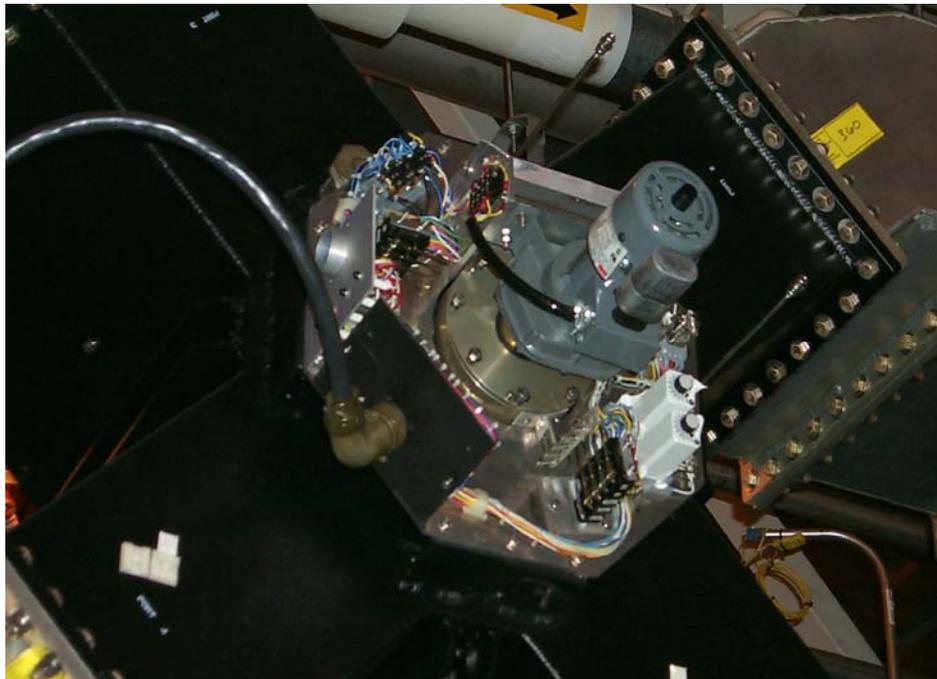
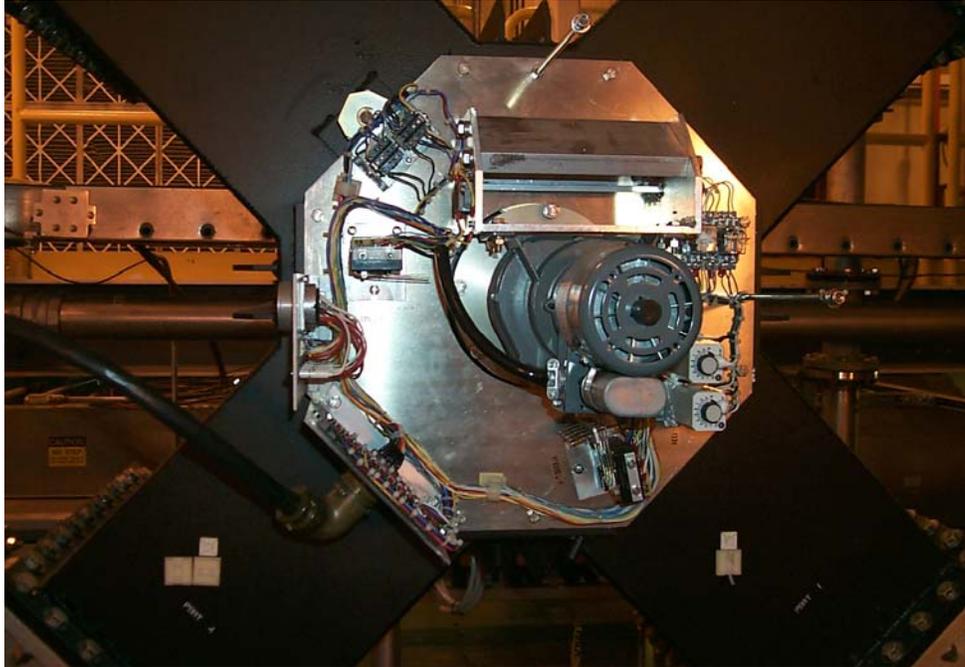
The interior of the waveguide switch showed no signs of arcing or excessive wear on rf contacts, and was clean and free of foreign matter. The following figures are interior views of the switch:

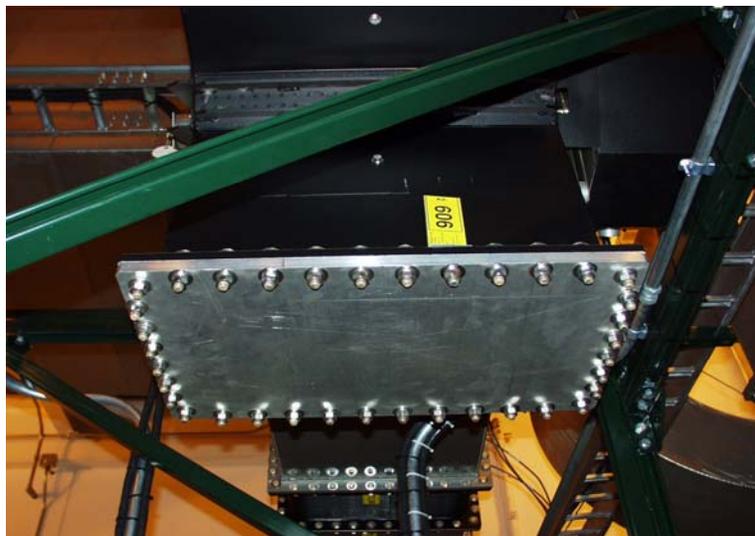
Figure 20 – Waveguide Switch #4

Access to the interior of this waveguide switch was made by removing the shorting plate terminating port #3 of the switch (at flange #909 – see figure 20):

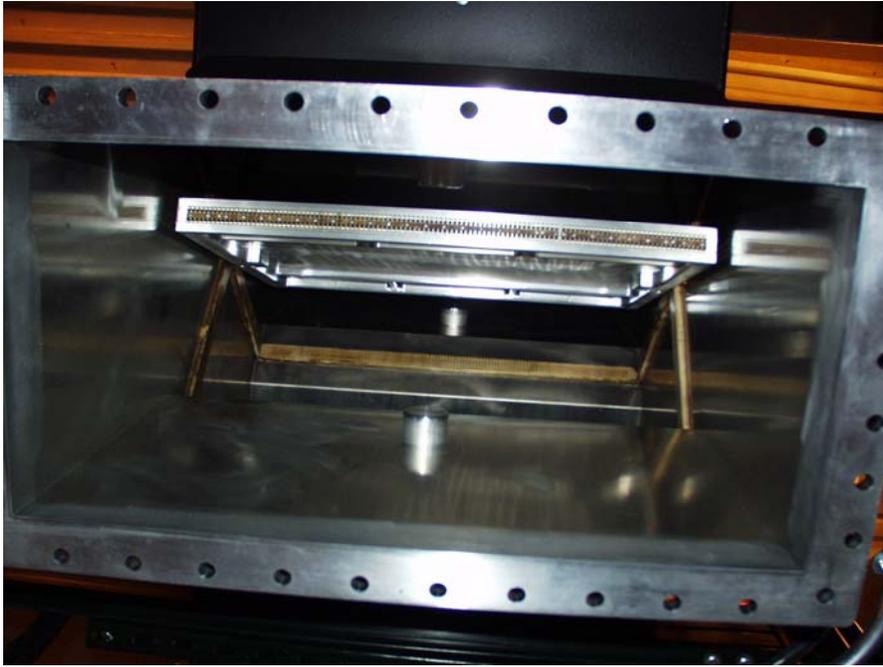
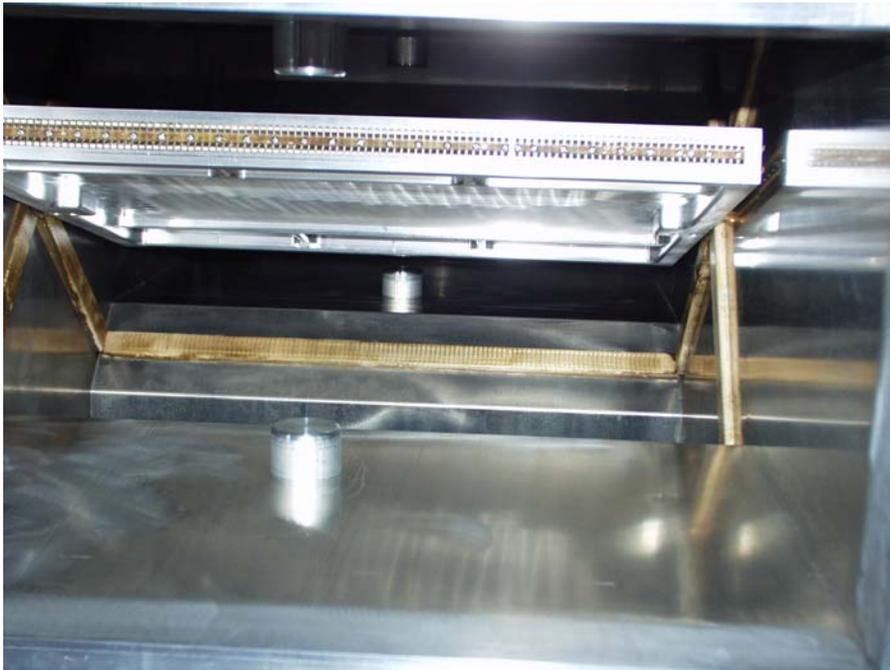
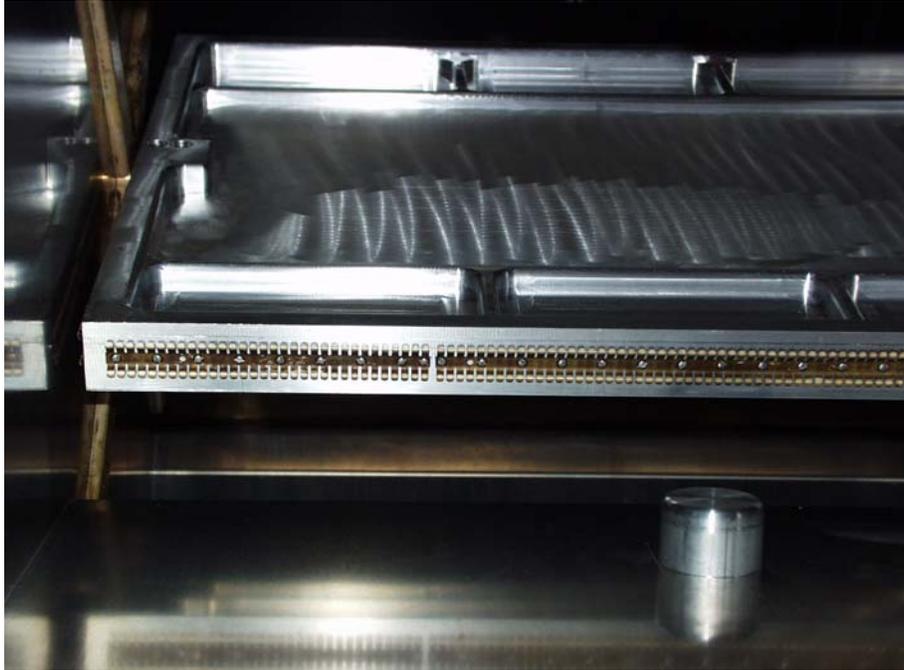
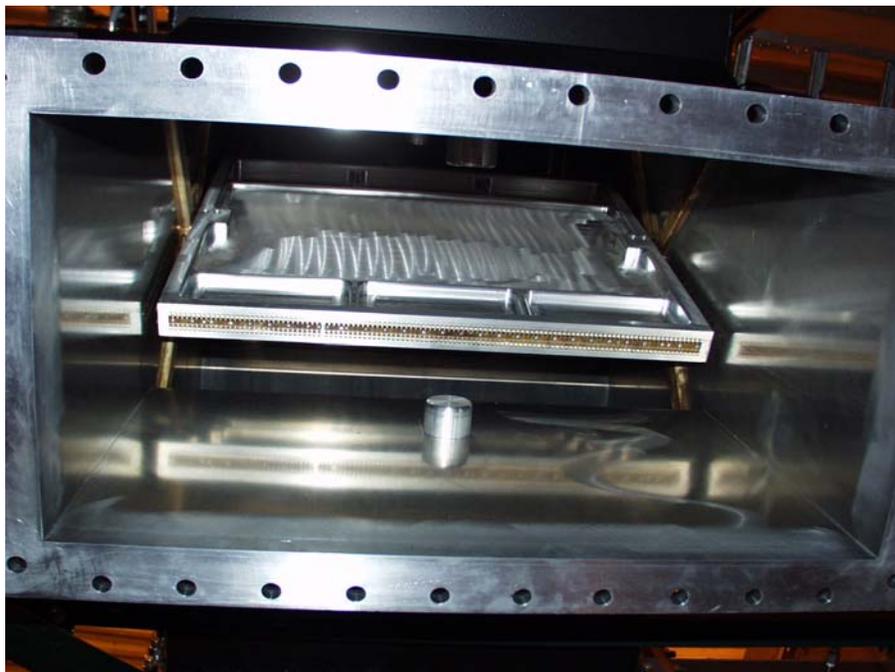
The interior of the waveguide switch showed no signs of arcing or excessive wear on rf contacts, and was clean and free of foreign matter. The following figures are interior views of the switch:

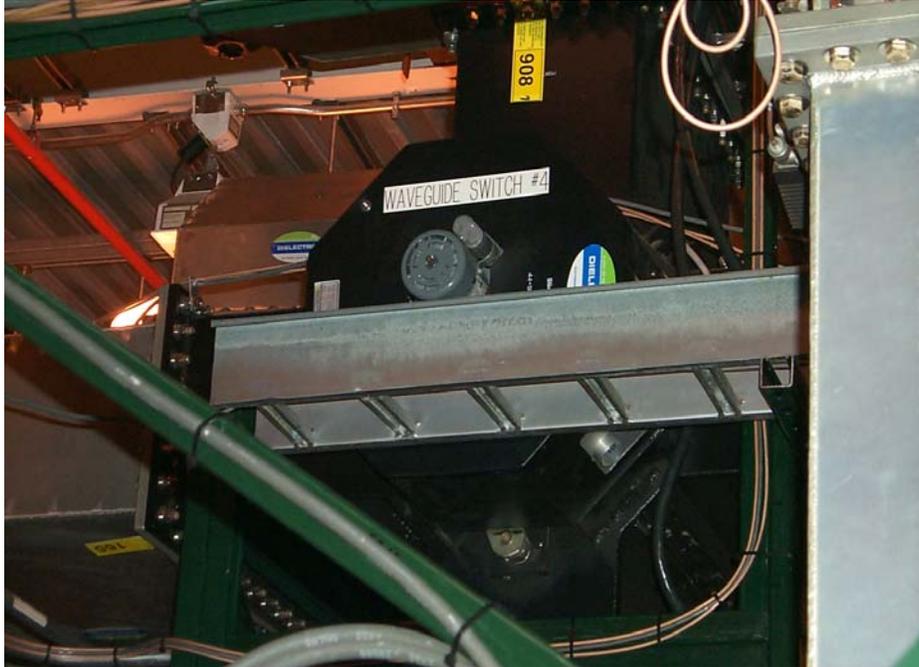
Figure 25 – Waveguide Switch #4

Note: The exterior motor drive components of waveguide switch #4 could not be inspected due to mechanical interference by a cable tray that was installed after the waveguide switch was installed (see Figure 25). This cable tray will be re-located after the December-January 2004/05 shutdown to allow clearance for inspection of the waveguide switch drive components.
